Failure Analysis: What Infrared Spectroscopy Can Tell You

by Dwight G. Weldon, Weldon Laboratories, Inc.

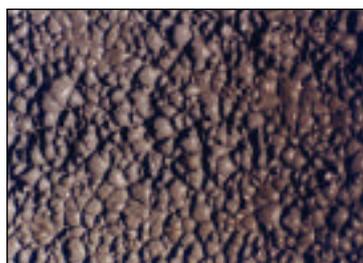
quire the use of the microscope, was that the back of the blistered coating was very rough. When examined microscopically, this roughness was due to an extensive "honeycomb" pattern in the urethane (Fig. 3).

The cell walls of the honeycomb were smooth and very glossy. Furthermore, examination of shavings removed from directly beneath a blister indicated the same type of honeycomb pattern in the gray urethane that had not lifted from the deck.

gested a reason: there appeared to be two coats of gray urethane, not the single coat called for in the specification. Furthermore, both coats were thicker than specified. The thickness of the honeycombed lower coat was difficult to judge because of the peaks and valleys of the honeycomb structure, but it averaged approximately 5 mils (125 micrometers). The upper urethane topcoat was 9–12 mils (225–300 micrometers) thick, compared to the specified value of 2–3 mils (50–75 micrometers).

Fig. 3: Back side of disbonded urethane topcoat showing dramatic honeycomb structure

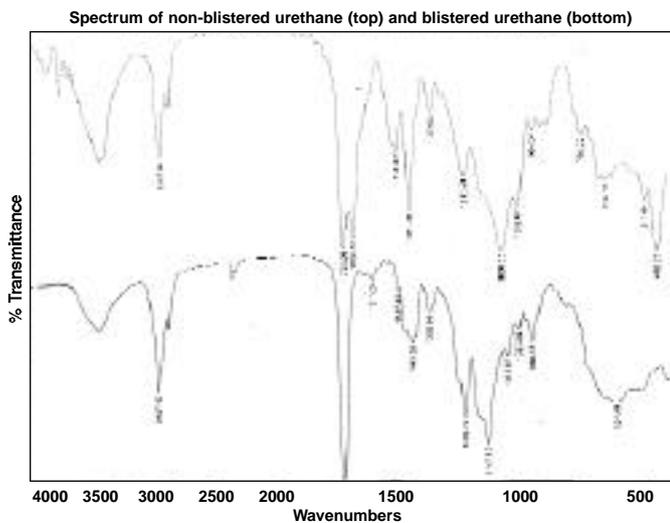
Figure 4 shows spectra of both the blistered, honeycombed urethane from a failed area and urethane topcoat from a non-blistered area. Even a cursory examination shows that the two spectra are considerably different. The spectrum of the non-failing coating is typical of a urethane, with characteristic bands near 1,725, 1,690, and 1,515 cm^{-1} . To understand the origin of these bands, one must have knowledge not only of spectroscopy but also of urethane chemistry.

With this background information in mind, it is apparent that not only are the spectra of blistered and non-blistered urethanes different from one another, but also the blistered urethane is really not a urethane at all. If it were, it would have a strong band due to the urethane carbonyl group near 1,690 cm^{-1} , as shown in the spectrum of the non-blistered topcoat. In fact, some additional laboratory work showed that the spectrum of the blistered “urethane” was quite similar to the spectrum of the Part A component of the coating (the acrylic polyol component), without the addition of any of the Part B isocyanate component.

In summary, it is apparent that the blistering of the coating system occurred in the few hundred square foot area because the contractor simply applied the Part A component of the two-component urethane, without mixing it with the Part B isocyanate component. The coating never cured because there was nothing for the acrylic polyol resin to react with. It is possible that the contractor realized this, since the topcoat was probably soft or sticky, and tried to fix it by applying a second coat of properly mixed urethane. This would explain why there were two coats of topcoat in the blistered area, rather than the specified single coat. Unfortunately, rather than fixing it, this “solution” just caused a different type of problem. The uncured, solvent-sensitive acrylic resin was partially redissolved by the solvents in the second, very thick coat (9–12 mils [225–300 micrometers]) vs. the speci-

Fig. 4: Infrared spectra of non-blistered urethane (top) and blistered urethane (bottom)

fied 2–3 mils [50–75 micrometers]), and it ruptured when this second coat cured and shrank. (All coatings shrink somewhat upon curing, imparting stress to lower layers.) The redissolving and rupturing of the first coat of “urethane” caused the formation of the honeycomb pattern and the blisters.

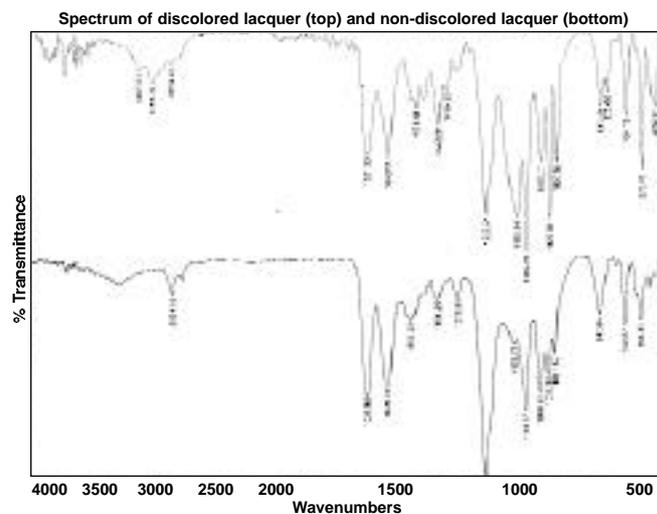
Fig. 5: Infrared spectra of discolored lacquer (top) and non-discolored lacquer (bottom)

Spectra were obtained of both discolored and non-discolored lacquer (Fig. 5). The spectrum of the non-discolored lacquer is rather complicated, but it is consistent with a coating consisting of an alkyd resin and a urea formaldehyde resin, which is a common recipe for a catalyzed or “conversion” varnish. These two resin types react upon the addition of a catalyst, often aided by a low-temperature bake.

An examination of the two spectra in Fig. 5 shows that there are marked differences between the discolored and non-discolored lacquers. The discolored sample has additional bands near 3,170, 3,060, 1,450, 1,150, and 1,025 cm^{-1} .

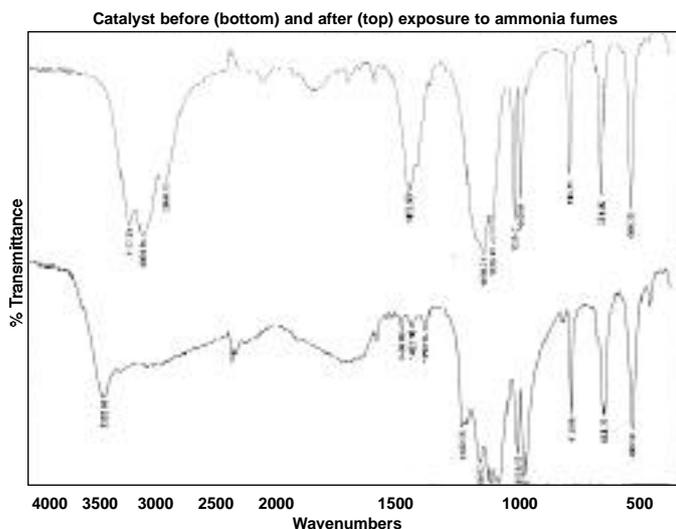
Fig. 6: Infrared spectra of catalyst before (bottom) and after (top) exposure to ammonia fumes

Figure 6 is the spectra of the catalyst component that was applied to a glass slide and allowed to dry, obtained both before and after exposure to ammonia fumes. The exposure to ammonia fumes resulted in dramatic changes to the spectrum, which included the appearance of strong bands near 3,170, 3,060, 1,450, and 1,150 cm^{-1} , the same locations of the “new” bands in the spectrum of the discolored lacquer. Furthermore, after exposure to the ammonia fumes, the catalyst changed from a clear material to a white material.

Based on the above observations and testing, the lacquer developed the milky white discoloration because of a reaction between the pTSA catalyst added to the lacquer and ammonia or an ammonia-based glass cleaner used by the office cleaning staff. Although it would take a fair amount of additional work to prove, it seemed likely that the catalyst was either added in excess or was not evenly distributed throughout the lacquer, and that the problem occurred in catalyst-rich areas.
