Failure Analysis: What Infrared Spectroscopy Can Tell You

by Dwight G. Weldon, Weldon Laboratories, Inc.

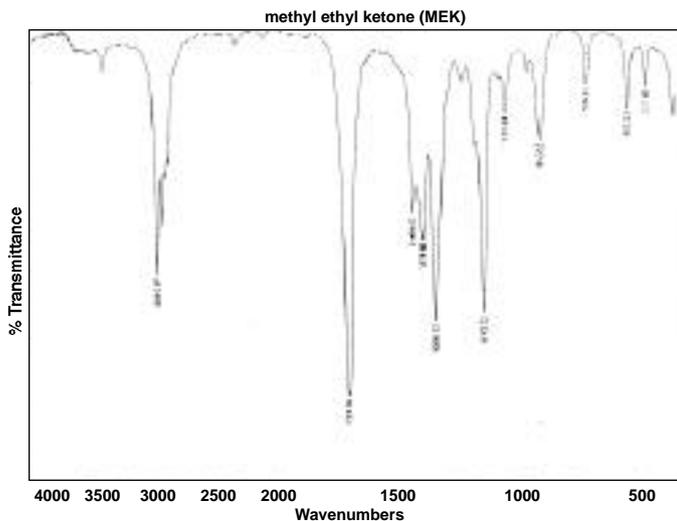
sorb infrared light at many different frequencies. The resulting infrared spectrum (Fig. 1) shows many different bands occurring at many different frequencies. Indeed, each molecule has its own unique infrared spectrum or "fingerprint." Some spectra

Fig. 1: Infrared spectrum of methyl ethyl ketone

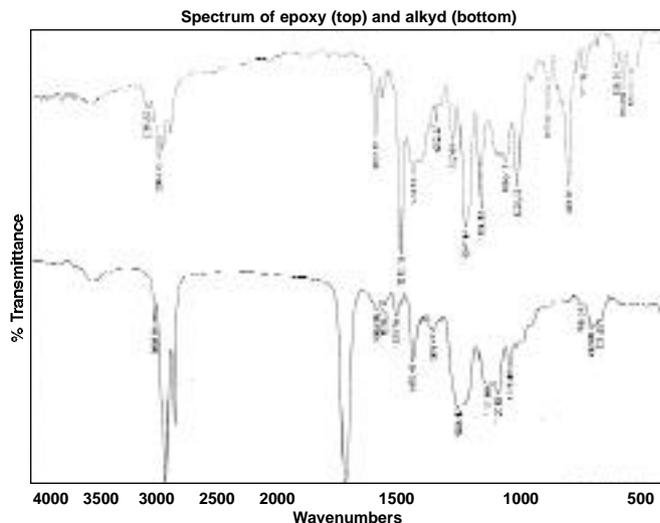
are very similar to one another, with only subtle differences, but some are dramatically different, such as the spectra of an alkyd resin and an epoxy resin, shown in Fig. 2. Perhaps the most useful collection of reference spectra for the coatings industry is the *Infrared Spectroscopy Atlas*,¹ while Mirabella² has published an excellent volume on technique and theory.

Fig. 2: Infrared spectra of an epoxy coating (top) and an alkyd coating (bottom)
